**APPENDIX G**  
**PERCOLATION TESTING REPORT**

**Subject: Percolation Testing  
24960 Adams Avenue  
Murrieta, California  
EEI Project NCO-73136.4a**

Reference: Geotechnical Investigation  
24960 Adams Avenue  
City of Murrieta, Riverside County,  
California 92562  
Assessor's Parcel Number (APN): 906-080-018  
By EEI, dated March 12, 2021, EEI Project No.NCO-73136.4

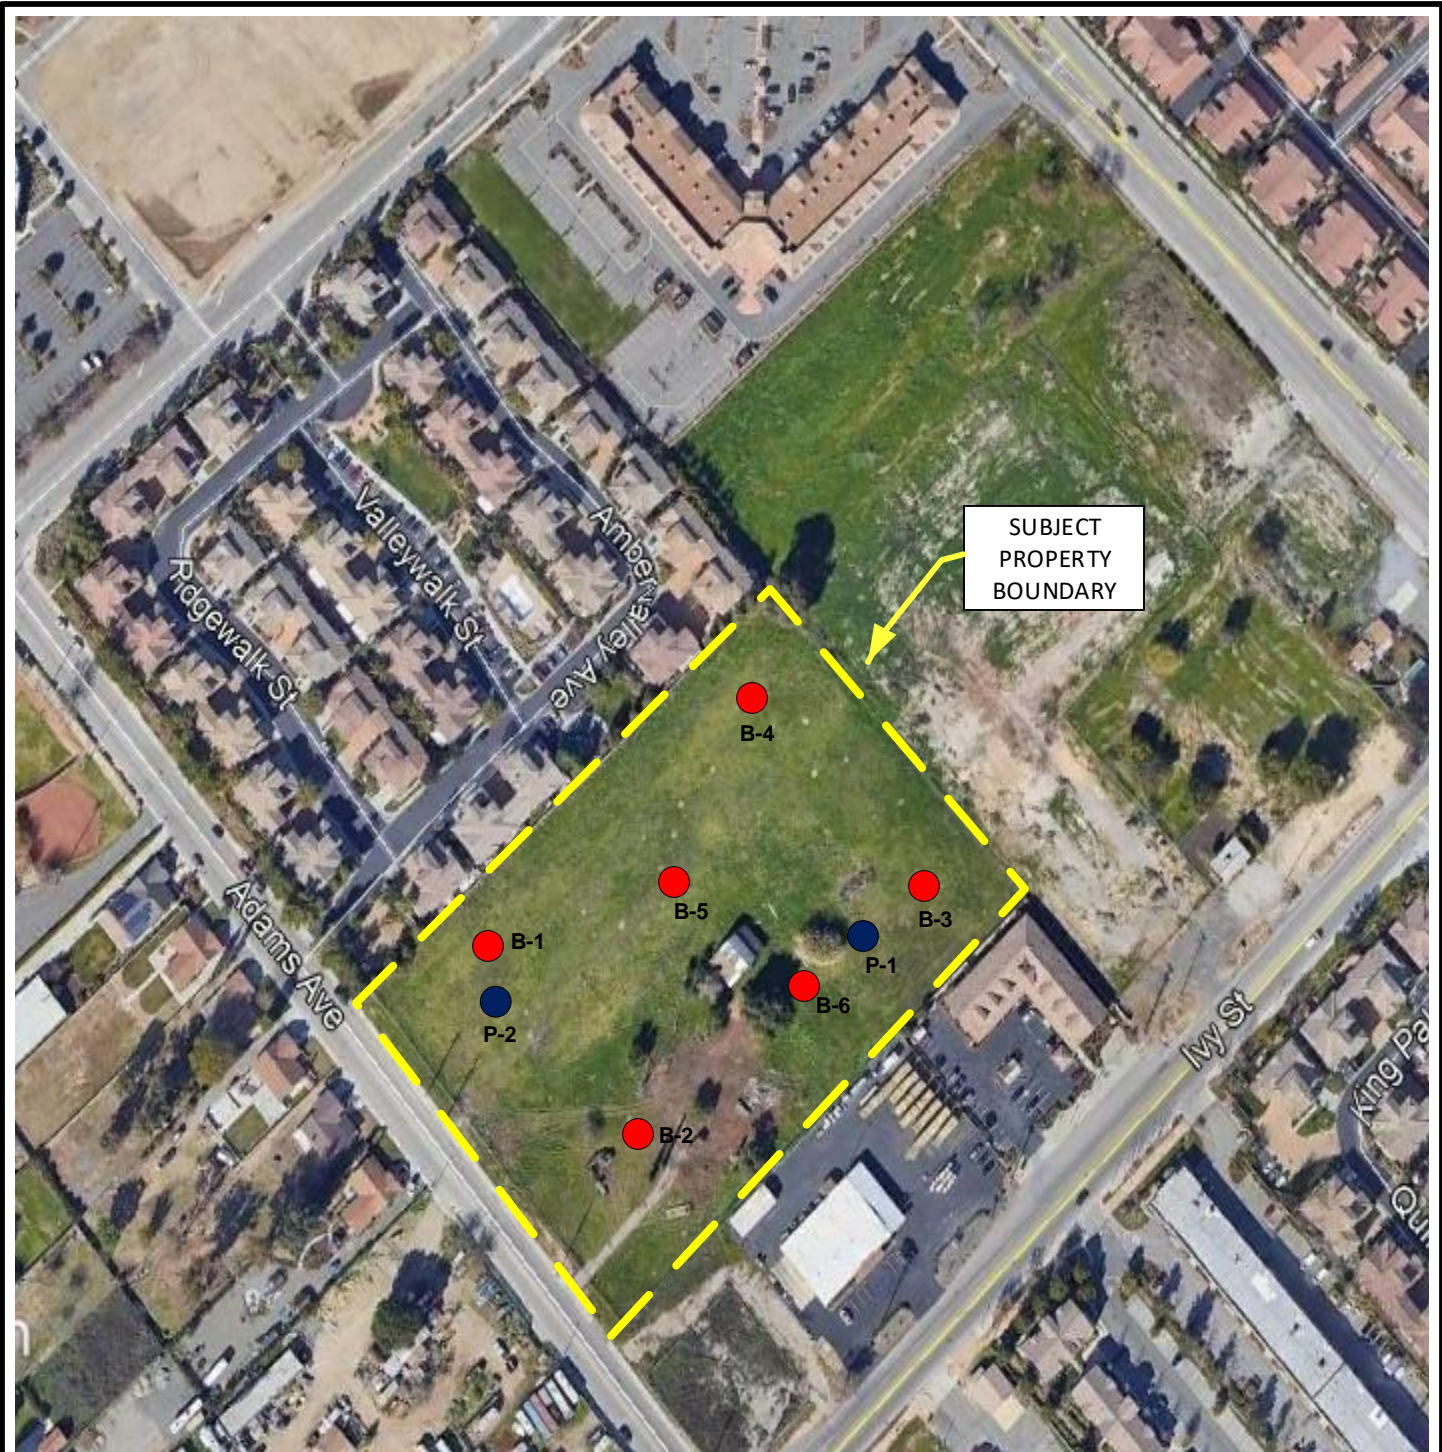
**FIGURE 1**

Two percolation tests were performed at the locations identified as P-1 and P-2. The approximate locations of the percolation tests are identified on Boring Location Map (**Figure 1**). Percolation test wells were constructed by inserting 3-inch-diameter perforated PVC pipe in the borings and backfilling the annular space with  $\frac{3}{8}$ -inch gravel to prevent caving during the percolation test. Following construction of the percolation test wells, they were filled with water and pre-saturated. Percolation testing was then performed, and consisted of refilling the test wells with water to approximate referenced elevation and taking a reading of drop in water level every ten minutes for a period of approximately one hour.

B-6 *Approximate Locations of exploratory borings*

P-2 *Approximate Locations of percolation tests*

**GEOTECHNICAL MAP**  
 National Community Renaissance  
**Proposed Residential Development**  
 24960 Adams Ave  
 APN 906-080-018  
 Murrieta, Riverside County, CA  
 EEI Project Number NOC-73136
